Contract #: 04-0120F4Cty: SF/ALA Rte: 80 PM: 13.2/13.9File #: 1x.28**WELDING INSPECTION REPORT****Resident Engineer:** Casey, William**Address:** 333 Burma Road**City:** Oakland, CA 94607**Report No:** WIR-026873**Date Inspected:** 14-Dec-2011**Project Name:** SAS Superstructure**OSM Arrival Time:** 630**Prime Contractor:** American Bridge/Fluor Enterprises, a JV**OSM Departure Time:** 1630**Contractor:** American Bridge/Fluor Enterprises, a JV**Location:** Job Site**CWI Name:** Bernie Docena**CWI Present:** Yes No**Inspected CWI report:** Yes No N/A**Rod Oven in Use:** Yes No N/A**Electrode to specification:** Yes No N/A**Weld Procedures Followed:** Yes No N/A**Qualified Welders:** Yes No N/A**Verified Joint Fit-up:** Yes No N/A**Approved Drawings:** Yes No N/A**Approved WPS:** Yes No N/A**Delayed / Cancelled:** Yes No N/A**Bridge No:** 34-0006**Component:** Bike Path - Skyway**Summary of Items Observed:**

WELDING INSPECTION REPORT

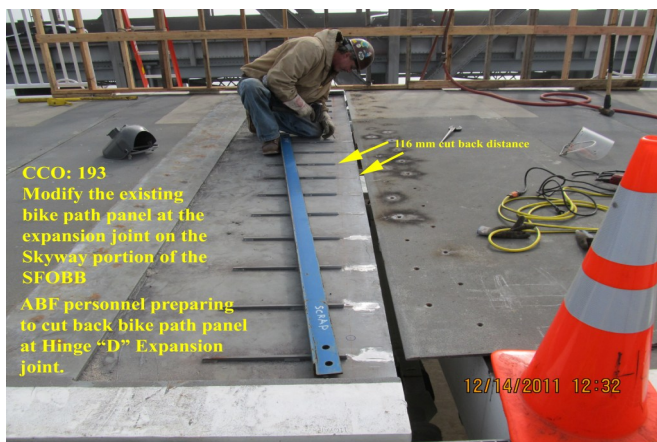
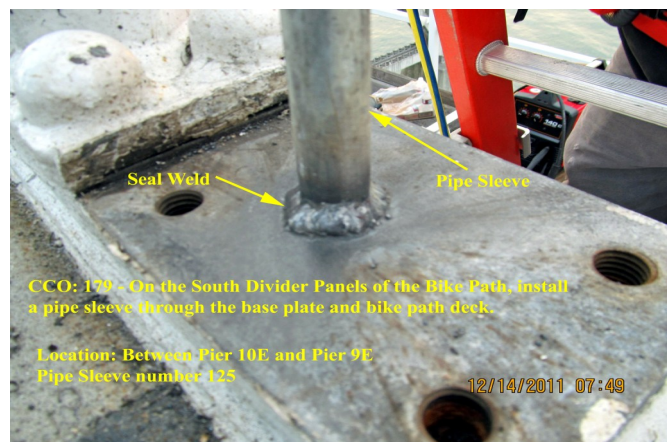
This QA Inspector observed ABF personnel drilling a 24 mm diameter hole through the 13 mm plate and 16 mm deck plate and centering the hole 19 +/- mm east of the centerline of the post base plate on the south rail dividers between Pier 10E and Pier 9E. This QA Inspector also observed the ABF personnel drilling a 27 mm diameter hole through the 8 mm bottom plate of the bike path panel for the installation of the pipe sleeve conduit pipe.

This QA Inspector observed ABF personnel preparing to cut back the top and side skin plate and diaphragm plate using an oxyacetylene cutting torch on a track system of the bike path panel at Hinge "D" Expansion Joint. The cut back distance is 116 mm as per Contract plan sheet number 1164S7 and ABF Submittal number 2549R1. This QA Inspector observed that the work was in progress at the end of this QA Inspectors' shift.
